ENVIRONMENTAL MANAGEMENT PRACTICES

4.1 Waste Management

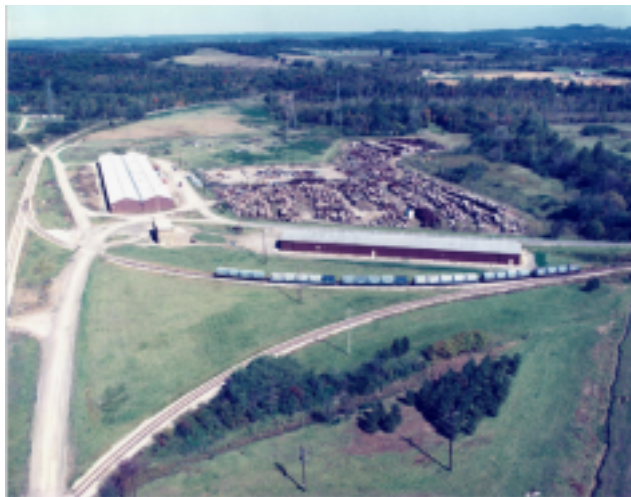
X-752 Scrap Yard with X-734 Spoils Area Directly Behind

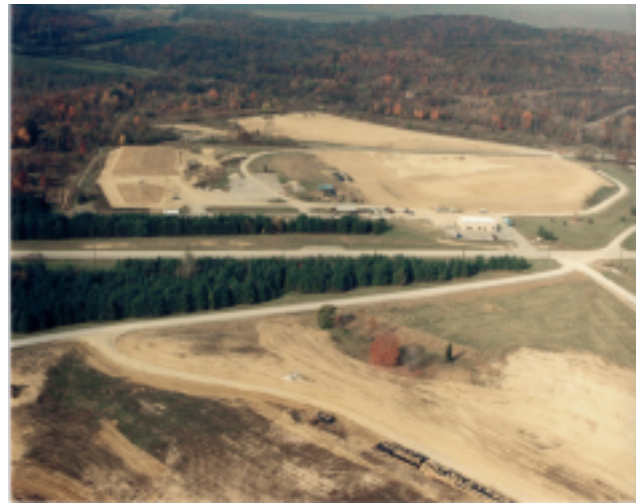
X-735 Landfill Area

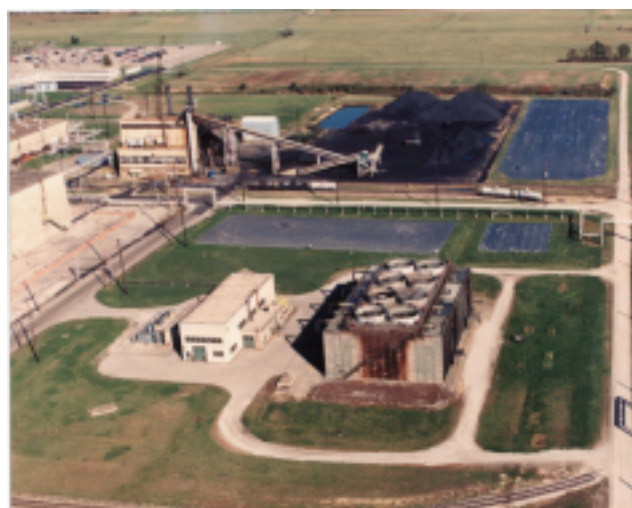
Biodegradation Plots (Beyond Cooling Towers)

prevent regulated waste streams from being placed on the plots; however, a June 1982 OR appraisal indicated that these controls were not always effective. A second plot (X-231B) continued to be used after the X-231A plot was closed in 1977. A July 1984 State of Ohio EPA inspection of X-231B found that no records were kept on quantities of solvents applied, that monitoring was not occurring in the unsaturated zone, and that closure and post-closure requirements needed to be addressed. By 1988, the State of Ohio EPA sent a notice of intent to file suit for hazardous waste violations. These violations included: operating the X-231B oil degradation facility without a permit; failing to establish an unsaturated zone monitoring program for X-231B; and placing hazardous waste on the X-231B plot without establishing a land treatment program or demonstrating that the waste would be completely degraded. As a result, the plot was closed and monitored for the presence of volatile organic compounds, PCBs, metals, and radioactive constituents.

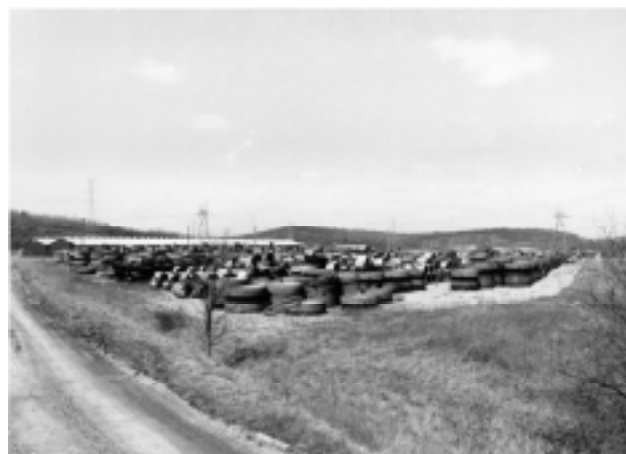
X-752 Scrap Yard

Despite the knowledge and proper corporate health and safety procedures instituted by Goodyear Atomic Corporation for scrap sales, the program encountered a number of problems, highlighted in internal memoranda and documents that began appearing in the mid-1970s. A September 1976 memorandum from Industrial Hygiene and Health Physics advised that insufficient manpower had resulted in an inability to survey each load of scrap unloaded at the concrete pad near Warehouse 15 and that recent surveys had identified a number of contaminated items. The problem escalated to a point that in September 1979, Industrial Hygiene and Health Physics recommended discontinuing the sale of scrap materials, based on concerns identified during an internal audit of the clean scrap yard. The problems included equipment directly associated with process gas, including blades, instrument lines, and peanut valves, present in material being loaded by a buyer. Surveys of these items indicated they were “highly contaminated.” The buyer also stated that he had previously purchased similar items; no evidence was provided to indicate that the Plant conducted any follow-up actions. Other concerns included observing unmonitored scrap and debris being dumped into the yard and handled by the buyer without the use of gloves. In addition, process housings with visible contamination were observed in the yard. In 1980, Goodyear Atomic Corporation issued a revised plan for control of scrap and trash material, along with a revised waste disposal procedure. Despite these changes, additional problems were noted in 1981 and 1982 during follow-up inspections at the clean scrap yard.

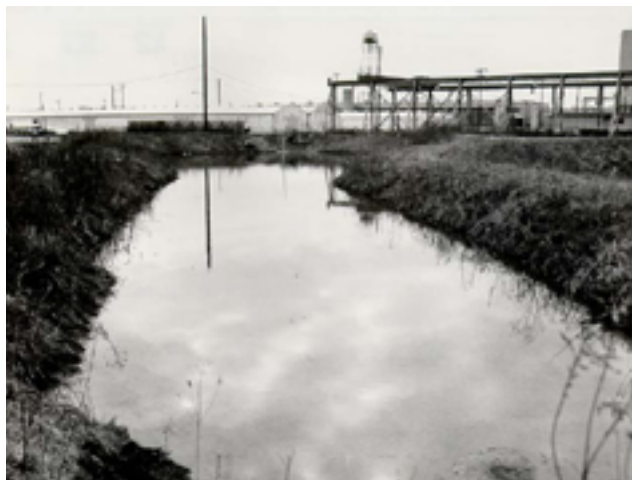
X-701B Holding Pond

The X-701B holding pond was a major effluent source to Little Beaver Creek. It was an unlined pond used for the neutralization and settling of metal-bearing waste water, solvent-contaminated solutions, and acidic waste water. Most of the waste discharged to the pond originated at the X-700 Chemical Cleaning Facility and the X-705 Decontamination Building, which was described previously. The X-700 Chemical Cleaning Facility contained, among other cleaning processes, two vapor degreasers, one of which had been in operation since 1955; the other had been used from 1955 until the early 1980s, when it was deactivated and removed from the building. TCE was used for degreasing until 1987; 1,1,1-trichloroethane has been used since. Floor drains in the basement of X-700 previously emptied into a ceramic pipe that discharged into a sump in the basement of X-700. The sump contents were then discharged to the X-701C pit, prior to entering the X-701B holding pond, until the pit was closed in 1988. This was a major source of TCE in X-701B and the entire east drainage ditch area.

From 1974 until 1988, slaked lime was added to the X-701B influent to neutralize the low pH and induce precipitation of uranium and trace quantities of transuranics. This precipitation caused a large amount of sludge to accumulate in the pond and necessitated annual dredging of the sludge. The X-701B holding pond was constructed early in Plant operations and received process discharges until November 1988.

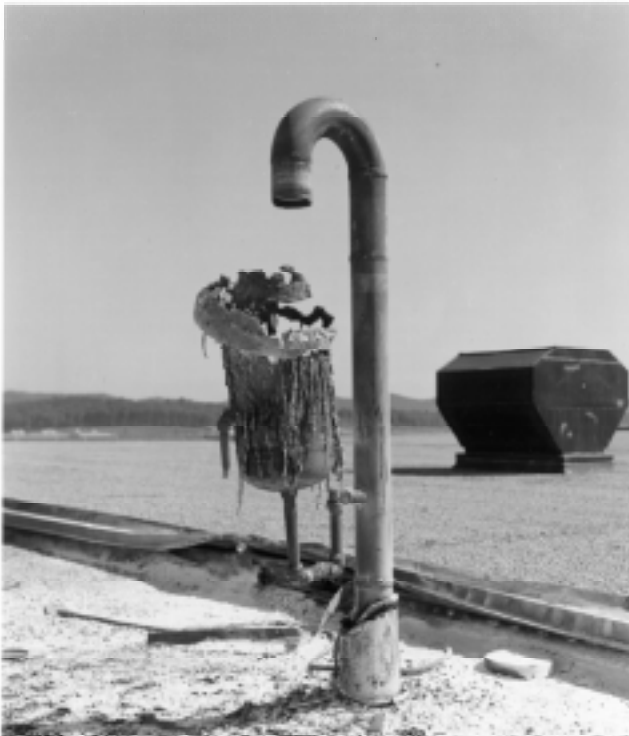
Roof Vent from X-330

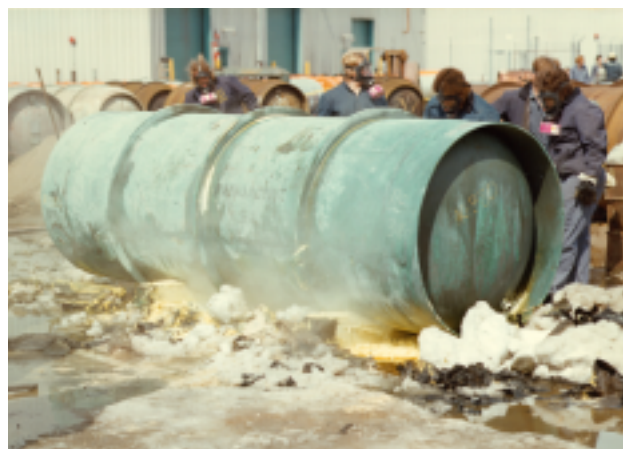
Cylinder Rupture
